Mercy Corps

Project Overview

Their new headquarters is comprised of the restoration of a 42,000 sf neglected historical landmark in a challenging urban district and an addition of similar size. An egalitarian layout and environmental features actualize Mercy Corps' mission to foster sustainable economic development through collaboration and self-empowerment while also helping to revitalize the neighborhood.

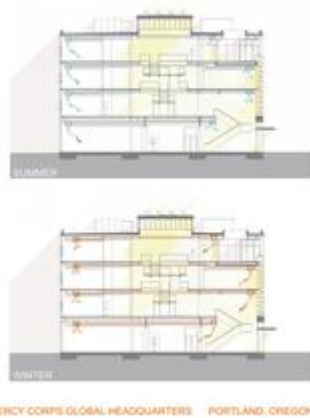
MERCY CORPS GLOBAL HEADQUARTERS PORTLAND, OREGON

*Mechanical Sections - Photo
Credit: THA Architecture*

The mechanical system was designed to be simple, decreasing operation and maintenance costs while operating efficiently and in conjunction with other strategies to reduce overall energy use. The grand staircase at the heart of the building acts as a ventilation stack, drawing air in and up through a monitor-controlled clerestory. Combined with operable windows, this strategy reduces any need to cool the building by drawing cool summer breezes from the north side to the south side of the building and stair stack. During the winter months, however, the north side of the building benefits from passive solar heat gain.

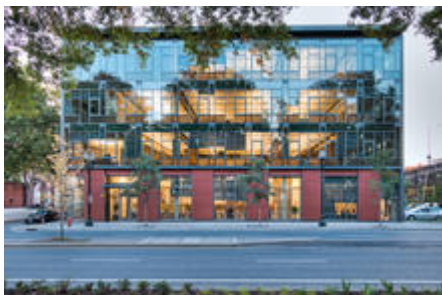
*Ample views and daylight
reach almost every occupant -
Photo Credit: Jeff Amram*

Ample views and daylight reach virtually every work space and increase the indoor environmental quality for the occupants. The furniture is pulled off the windows and uses low, translucent end panels for equitable access to daylight through the space. Efficient lighting design and sensors work with the natural light to reduce overall lighting loads. Individual task lighting also reduces the need for ambient lighting.

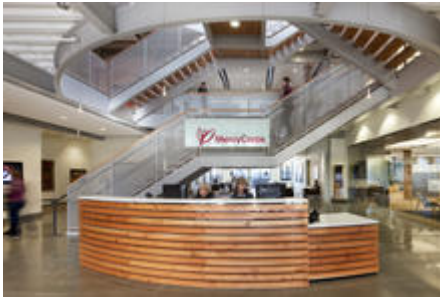
Wood from the existing building was used in finish elements at the reception desk and on the main stair - Photo Credit: Lara Swimmer

87% of the existing historic Packer-Scott building was re-used. Wood from the existing building was used in finish elements in the new addition in the main stair treads and the reception desk as well as at the coffee bars. During construction, 95% of the waste was diverted from the landfill through recycling or reuse.

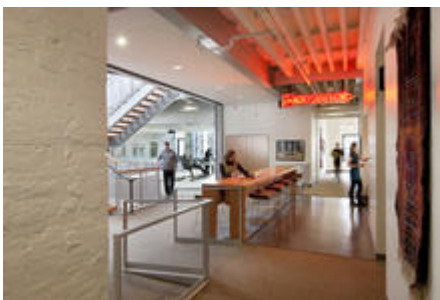
Structural systems were left exposed and minimal finishes applied to save materials - Photo Credit: Lara Swimmer

Structural systems were left exposed and minimal finishes applied to save materials. The raw background is then offset by colorful artwork and artifacts collected from around the world, which inspired the building design, resulting in a simple yet rich environment.
